# ENVIRONMENTAL IMPACT ASSESSMENT

PREPARED FOR THE DAILY LOCAL  
TOWNHOMES SITE LOCATED IN EAST  
BRADFORD TOWNSHIP, CHESTER COUNTY, PA

PREPARED BY ESE CONSULTANTS, INC.

## **Daily Local Townhomes Site: Environmental Impact Assessment**

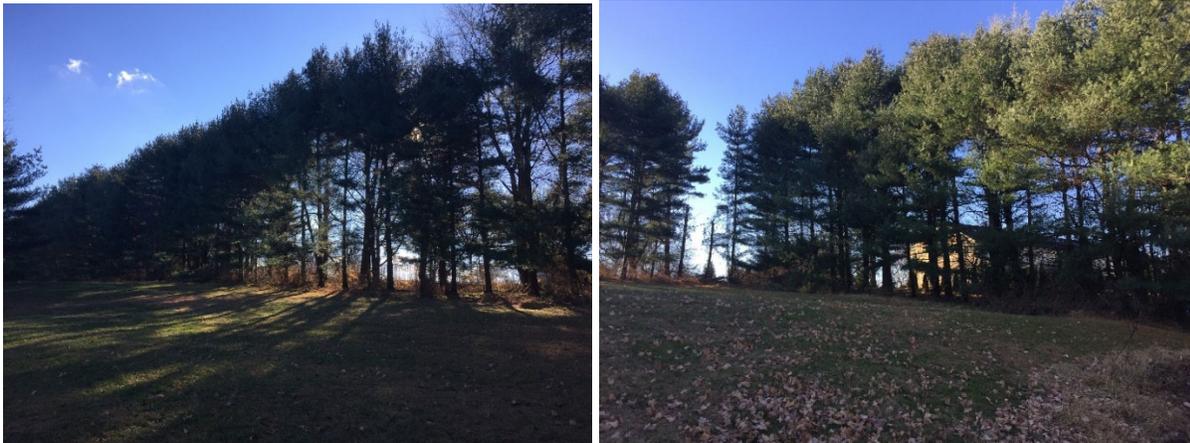
Most of the project site has been altered from its natural vegetation conditions. Approximately 1.41 acres of area classified as woodlands exist along the southern and western perimeters of the site. This area is made up predominately of mature white pines. The southeastern corner of the property contains a small pocket of maple trees, most ranging from 8-14 inches in caliper.

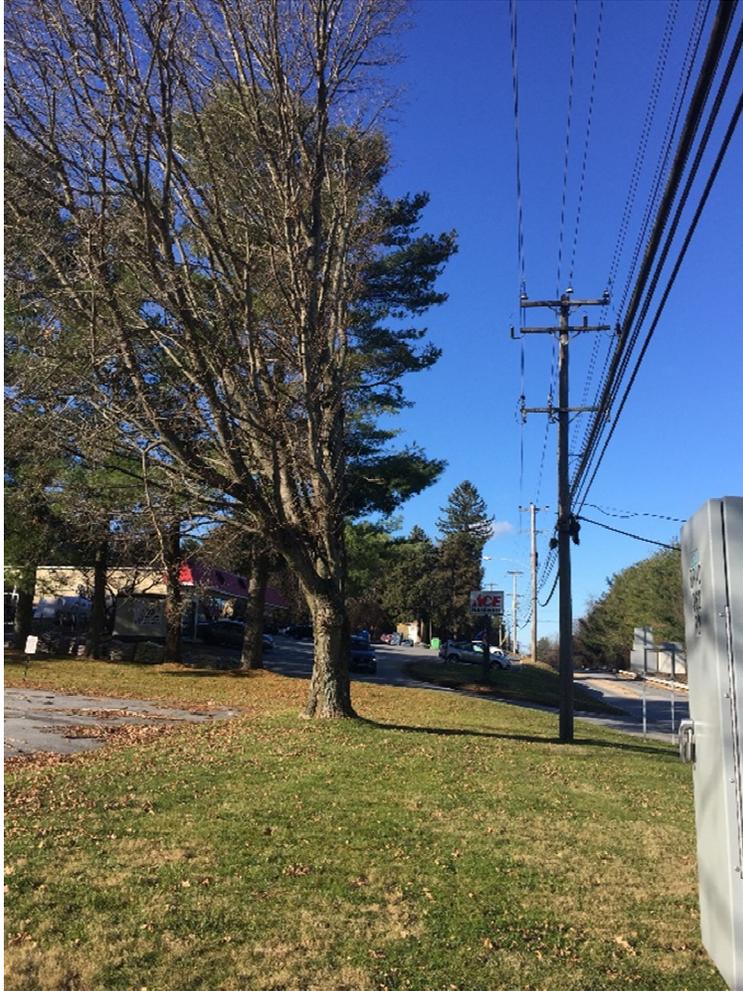
White pines: Southern and Western Property lines

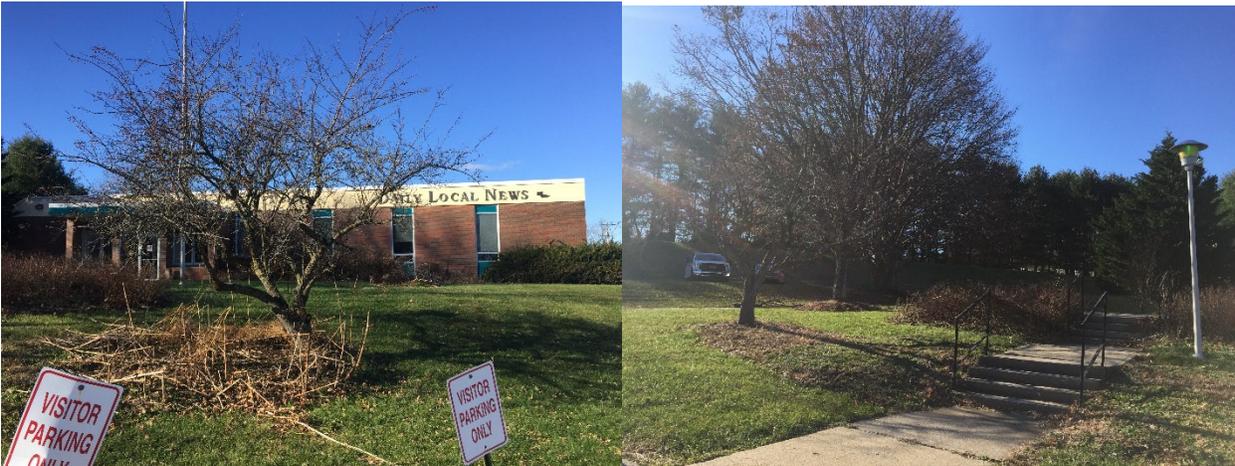
Standalone shade trees: (2) 28” caliper sugar maples near the existing entrance along Strasburg Road. These have been heavily trimmed due to proximity to adjacent power lines.

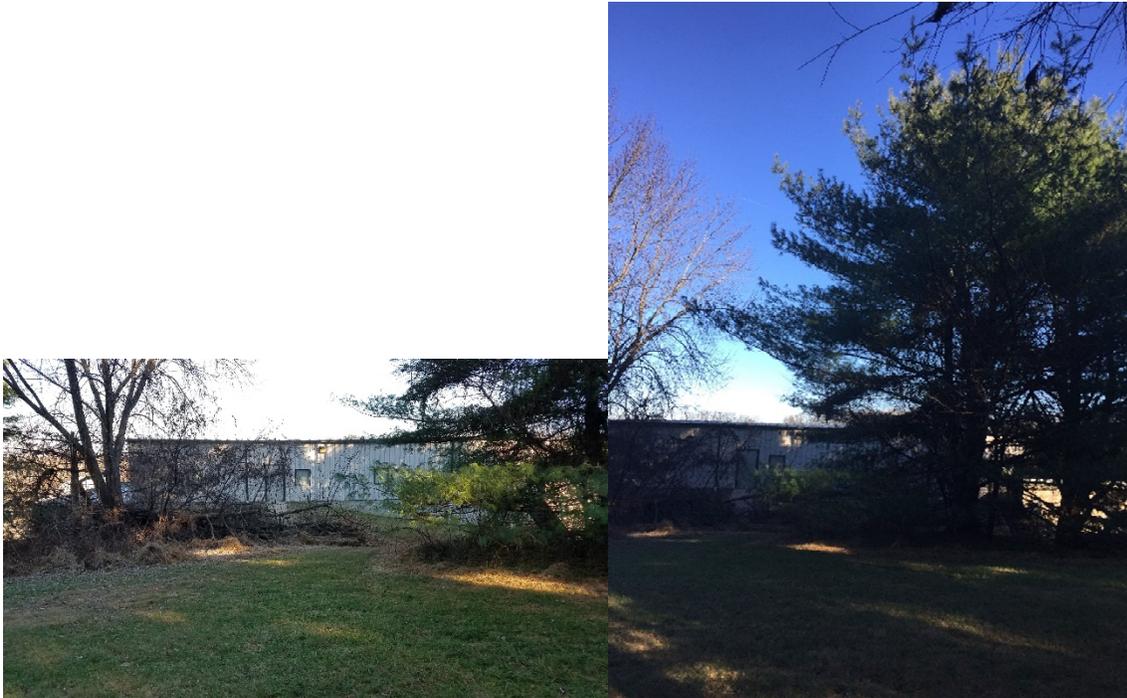
The portion of the site where building faces Bradford Avenue has a small area of maintained landscape beds consisting of several crabapple trees, several maple trees, foundation shrub plantings and seasonal perennial/annual beds.

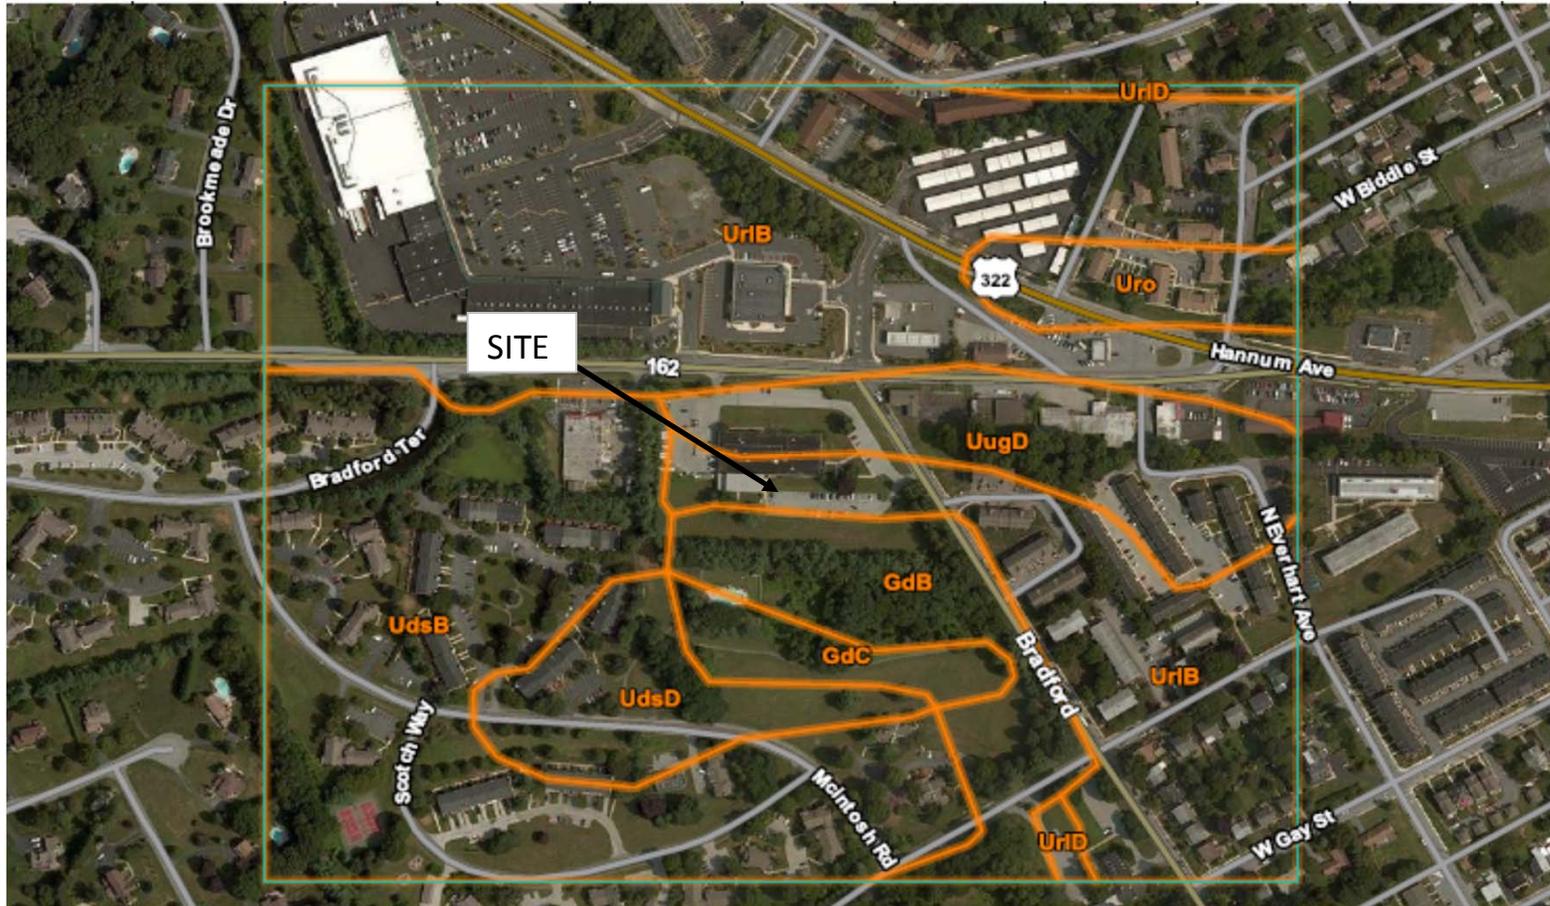
Gladstone gravelly loam, 3 to 8 percent slopes (GdB)
