ENVIRONMENTAL IMPACT ASSESSMENT

PREPARED FOR THE TIGUE PROPERTY
LOCATED IN EAST BRADFORD TOWNSHIP,
CHESTER COUNTY, PA

PREPARED BY ESE CONSULTANTS, INC.

1/19/2016

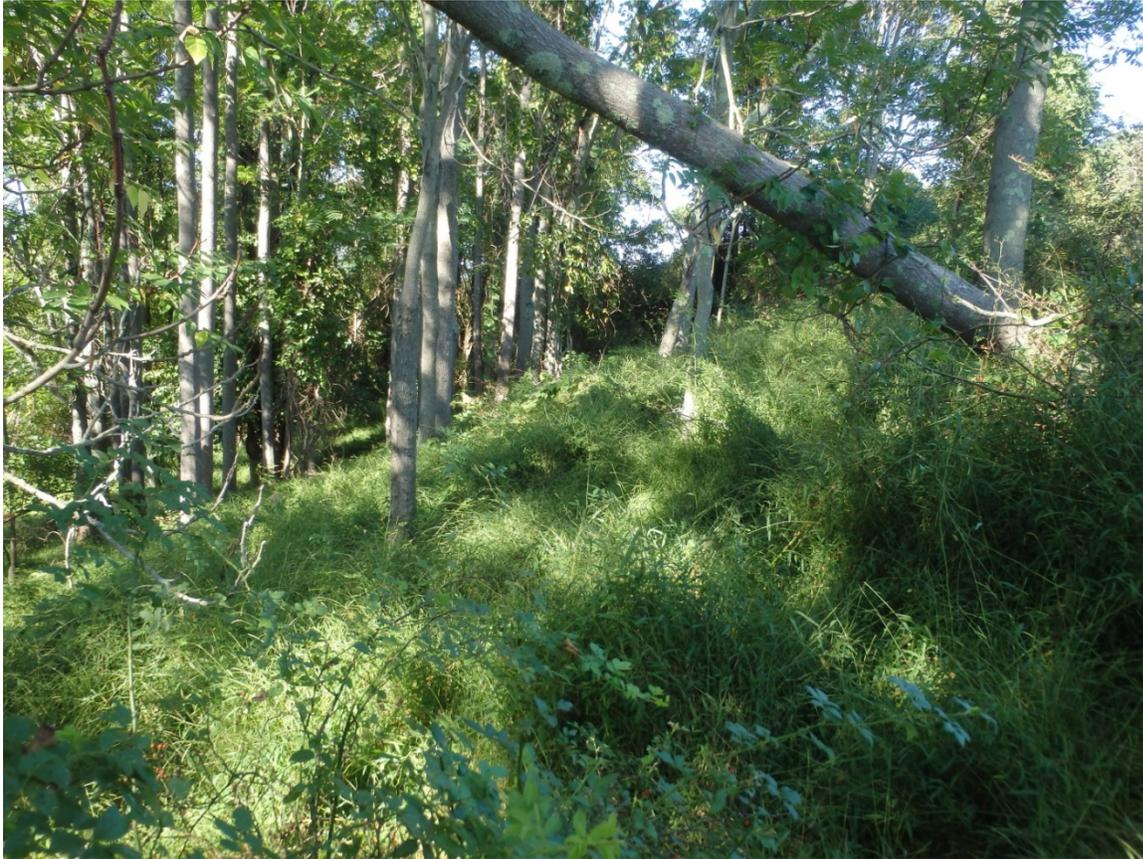
It is notable that Japanese stiltgrass dominates the herbaceous communities where tree canopies are incomplete. In addition, a virtual monoculture of Tree of heaven forms a wooded cluster within the open meadow on the south side of Tigue Road. The herbaceous and shrub communities are also dominated by invasive species such as Japanese stiltgrass, multiflora rose, and autumn olive and can be seen in the photo below:

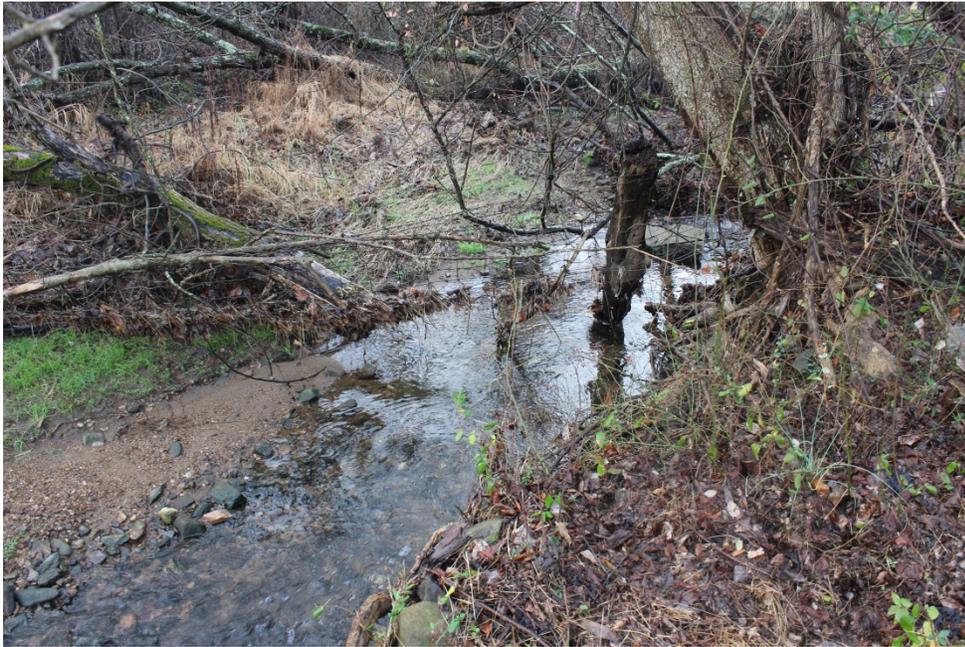
Plum Run: Northern Parcel

As is typical with most streams, there are areas of erosion located along the stream channel of Plum Run and its un-named tributary on both the Northern and Southern parcels as indicated by the photographic evidence below;

4.)	INCREASE OF IMPERVIOUS SURFACE	DECREASE IN GROUNDWATER RECHARGE, INCREASED STORM WATER RUN-OFF AND VELOCITY, POTENTIAL FOR STREAM BANK EROSION	STORM WATER BASINS AND OTHER BMPs WILL BE UTILIZED TO INTERCEPT STORM WATER RUNOFF TO HELP SLOW VELOCITY, INCREASE INFILTRATION, PROMOTE WATER QUALITY AND PROTECT ADJACENT STREAMS FROM FURTHER EROSION
